National Dam Inspection Program. Oneida
Mining Co. Dam (NDI PA-830), Ohio River
Basin, Unnamed Tributary to Brush Creek,
Indiana County, Pennsylvania. Phase I
Inspection Report.

PHASE I REPORT
NATIONAL DAM INSPECTION PROGRAM

Oneida Mining Company Dam

26 September 78 (visual inspection)

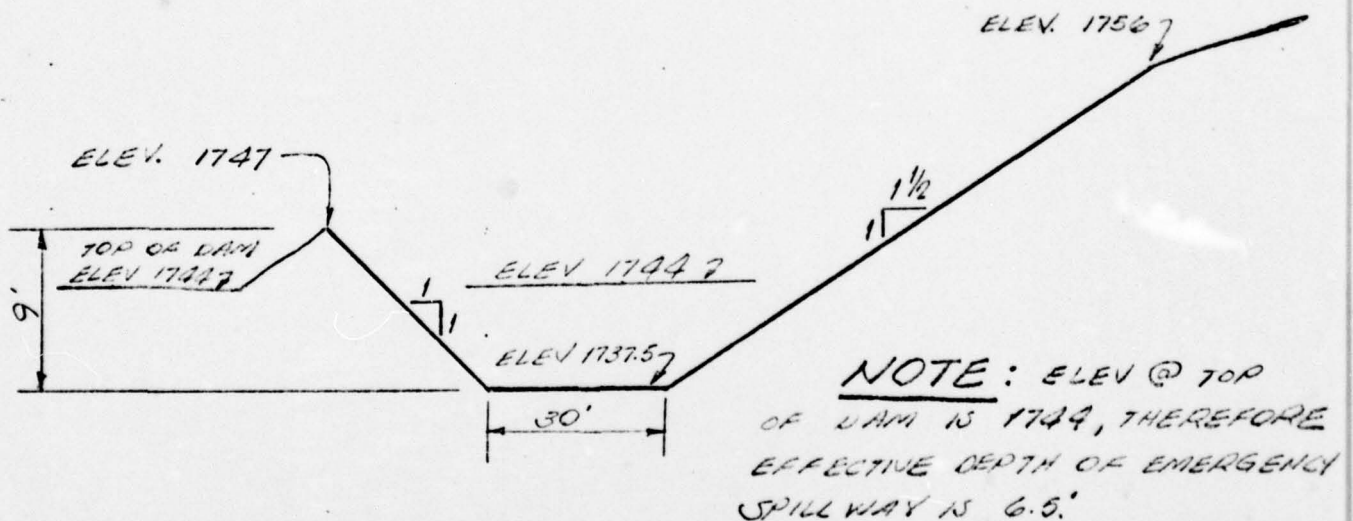
FIG. 1

THE EMERGENCY SPILLWAY IS A GRASS LINED
EARTHEN TRENCH HAVING THE CROSSSECTION
SHOWN BELOW:

ALL ELEVATIONS, DETAILS, AND DIMENSIONS ARE TAKEN
FROM REF 1, DWG 5 OF 11, AND HAVE BEEN FIELD
VERIFIED.

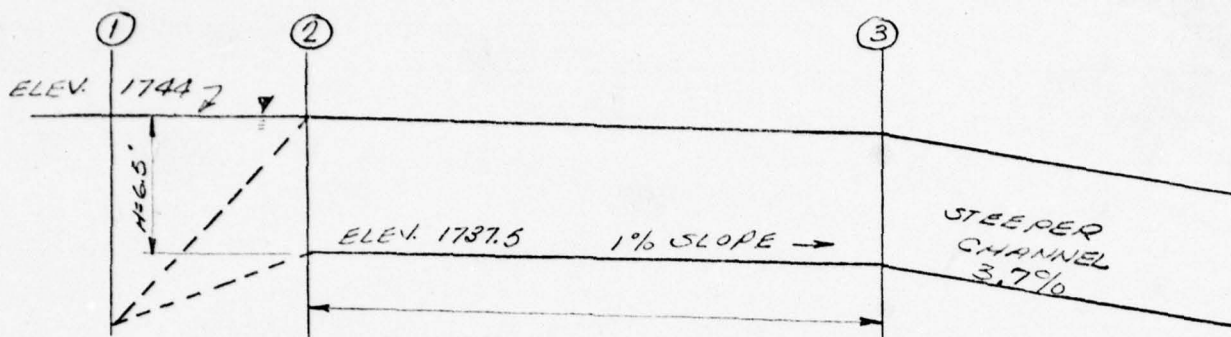
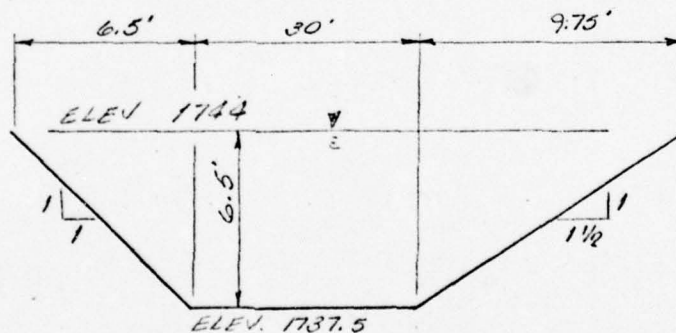
FIGURE 2

ALL ELEVATIONS, DETAILS, AND DIMENSIONS ARE TAKEN FROM
 REF 1, DWG 2 OF 11, AND HAVE BEEN FIELD VERIFIED

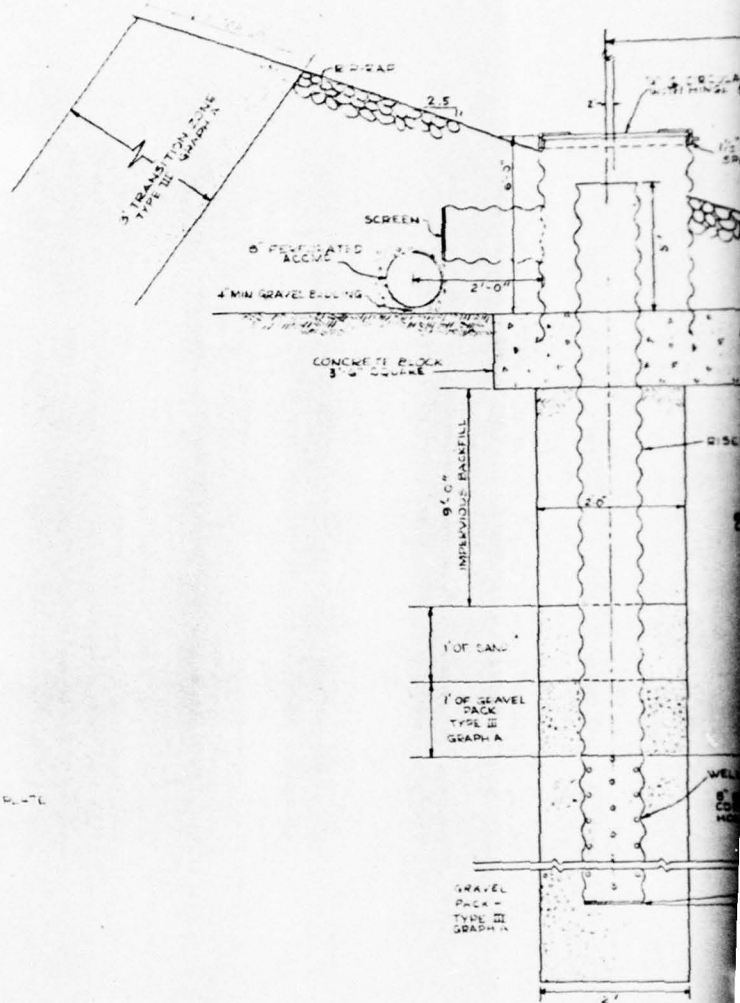
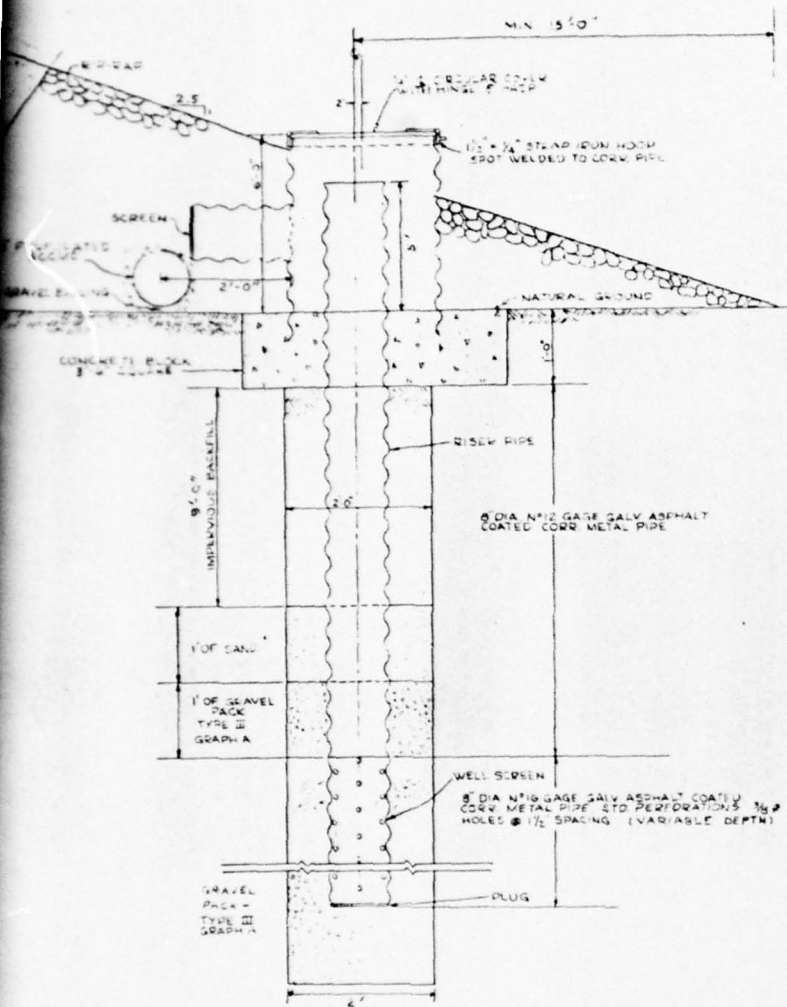
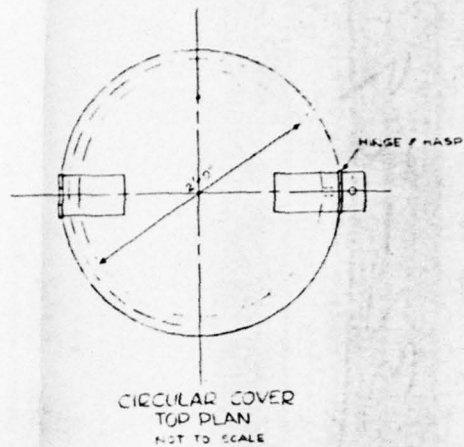
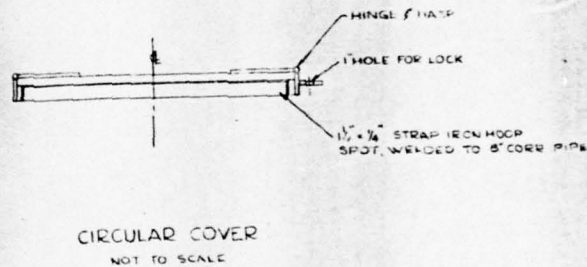
FIGURE 9

required the installation of relief wells in the downstream rock toe. Between the relief wells are 8 observation wells. The downstream toe relief and observation wells are installed to a depth of approximately 35 feet and extend from Station 15+00 to Station 19+00. Figure 9 gives the construction detail for a typical relief well. The plan of the embankment (see Figure 5) shows the location of the downstream relief and observation wells.
